Marine Accident Report

Fire On Board the Small Passenger Vessel *Port Imperial Manhattan*, Hudson River New York City, New York November 17, 2000

**National
Transportation
Safety Board**
Washington, D.C.

**NTSB/MAR-02/02
PB2002-916402
Notation 7472
Adopted June 11, 2002**

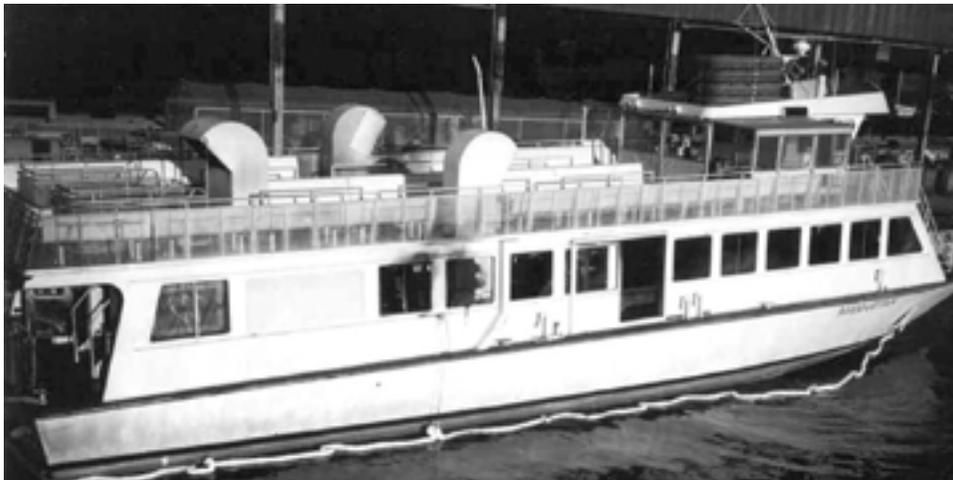
Figure 1. The *Port Imperial Manhattan*, a commuter service vessel, was certificated by the U.S. Coast Guard (Coast Guard) pursuant to 46 *Code of Federal Regulations* (CFR) Subchapter T “Small Passenger Vessels (Under 100 Gross Tons).” Additional information about its construction appears later in this report, under “Vessel Information.”
